Design, Construction, and Analysis of CRCP Patching Techniques

Physical Research Report No. 124

March 1998

Illinois Department of Transportation
Bureau of Materials and Physical Research

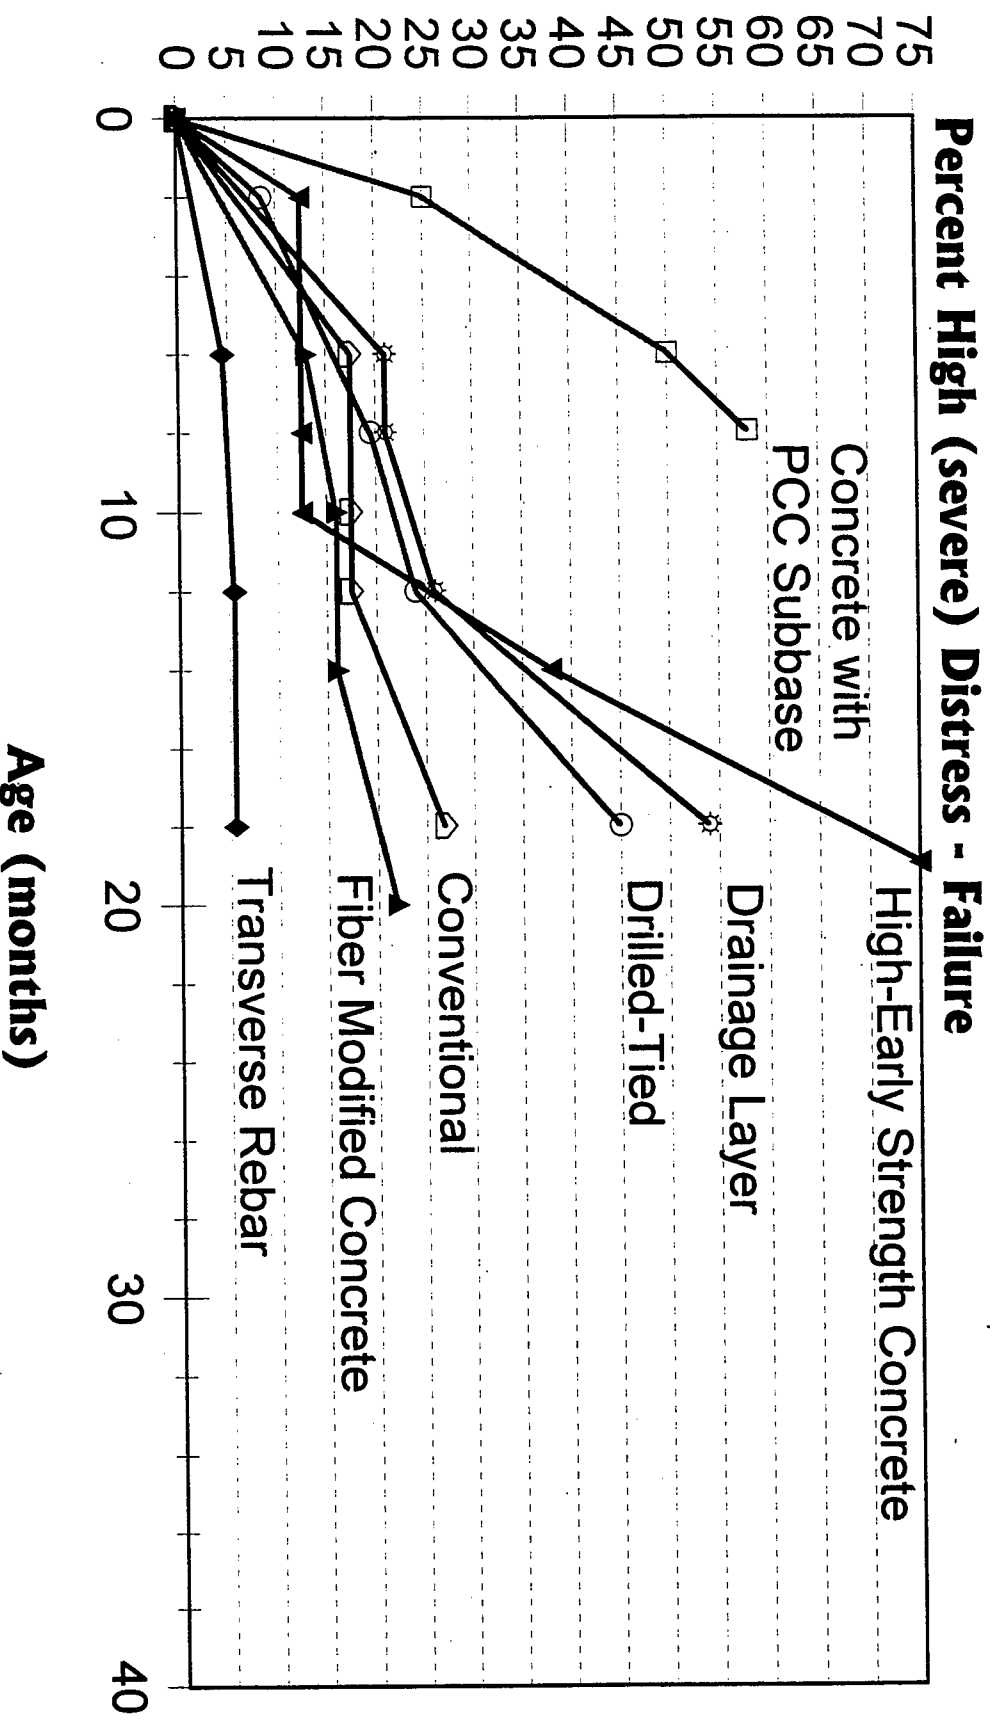
Figure 2. Comparison of CRCP Patch Performance

The survey data in Figure 2 presents the percentages of patch failures for each CRCP patch design throughout the study period. Only the Transverse Rebar and Steel Fiber Modified Concrete patch designs exhibited lower failure rates than the conventional Class A design. Data was also collected on distresses and categorized by percentages of low and medium, as well as higher failures for each patch design. A patch listed in the low distress category features minor spalls (less than 5) and corner breaks (less than 2). Tight, hairline transverse cracks are considered low severity and not counted as a distress. A patch in the medium distress category will have medium severity transverse and/or longitudinal cracks, plus any or all of the distresses listed in the low distress category. A patch in the high distress category will have high severity transverse and/or longitudinal cracks, plus spalls and/or punch outs. Failed patch distresses may include pumping of fines, adjacent pavement breakup, partial patch replacement, or have a combination of these factors. The extent of each distress is measured by the number of areas of distress at each severity level.

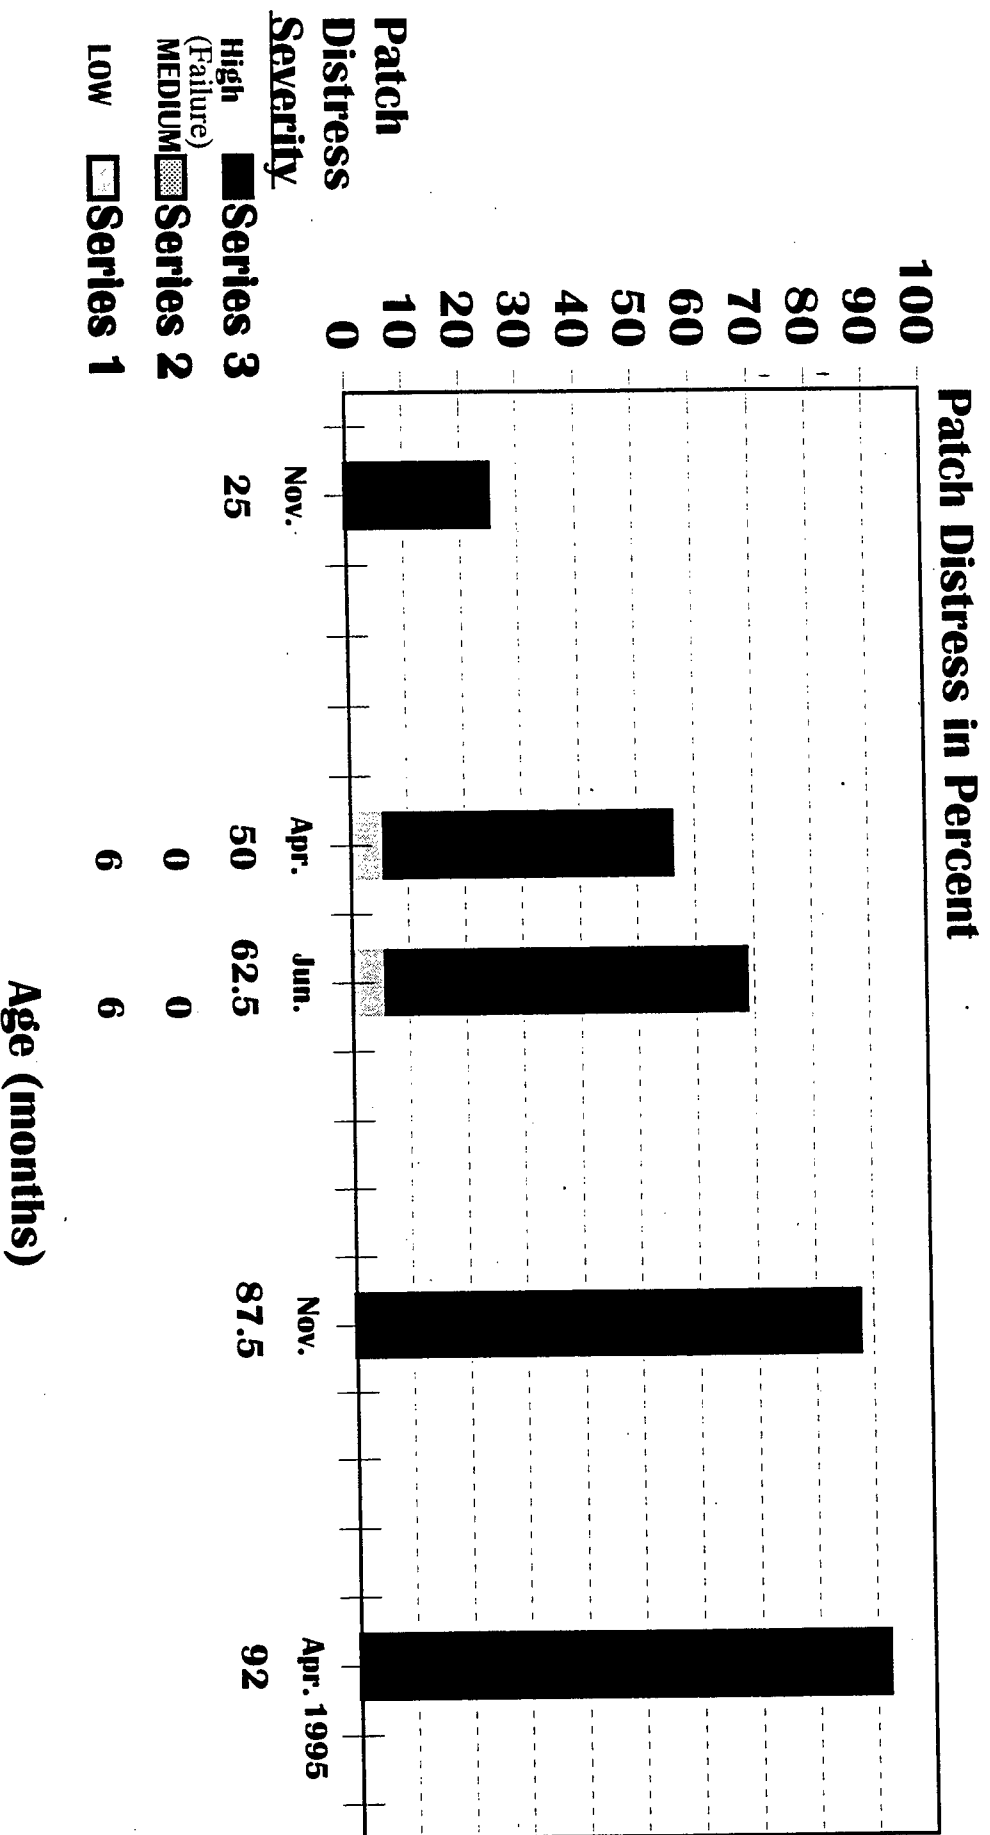
Figure 4. Remove and Replace Subbase Patch Design

This design is more costly and time consuming than the average rate for the conventional Class A patch. There were 13 patches constructed and studied using this procedure. These patches were located at Site 5 in Douglas County. This site consisted of a highly deteriorated 180 mm (7-inch) thick CRCP, as shown in Figure 4. Survey data analysis indicates a 92% patch failure rate after 2 years. Inconsistencies in subbase support is believed to be the cause of failures. Due to the low number of patches constructed, the performance of this design may not be representative of statewide experience. Typical failures are shown in Photos 8-10.

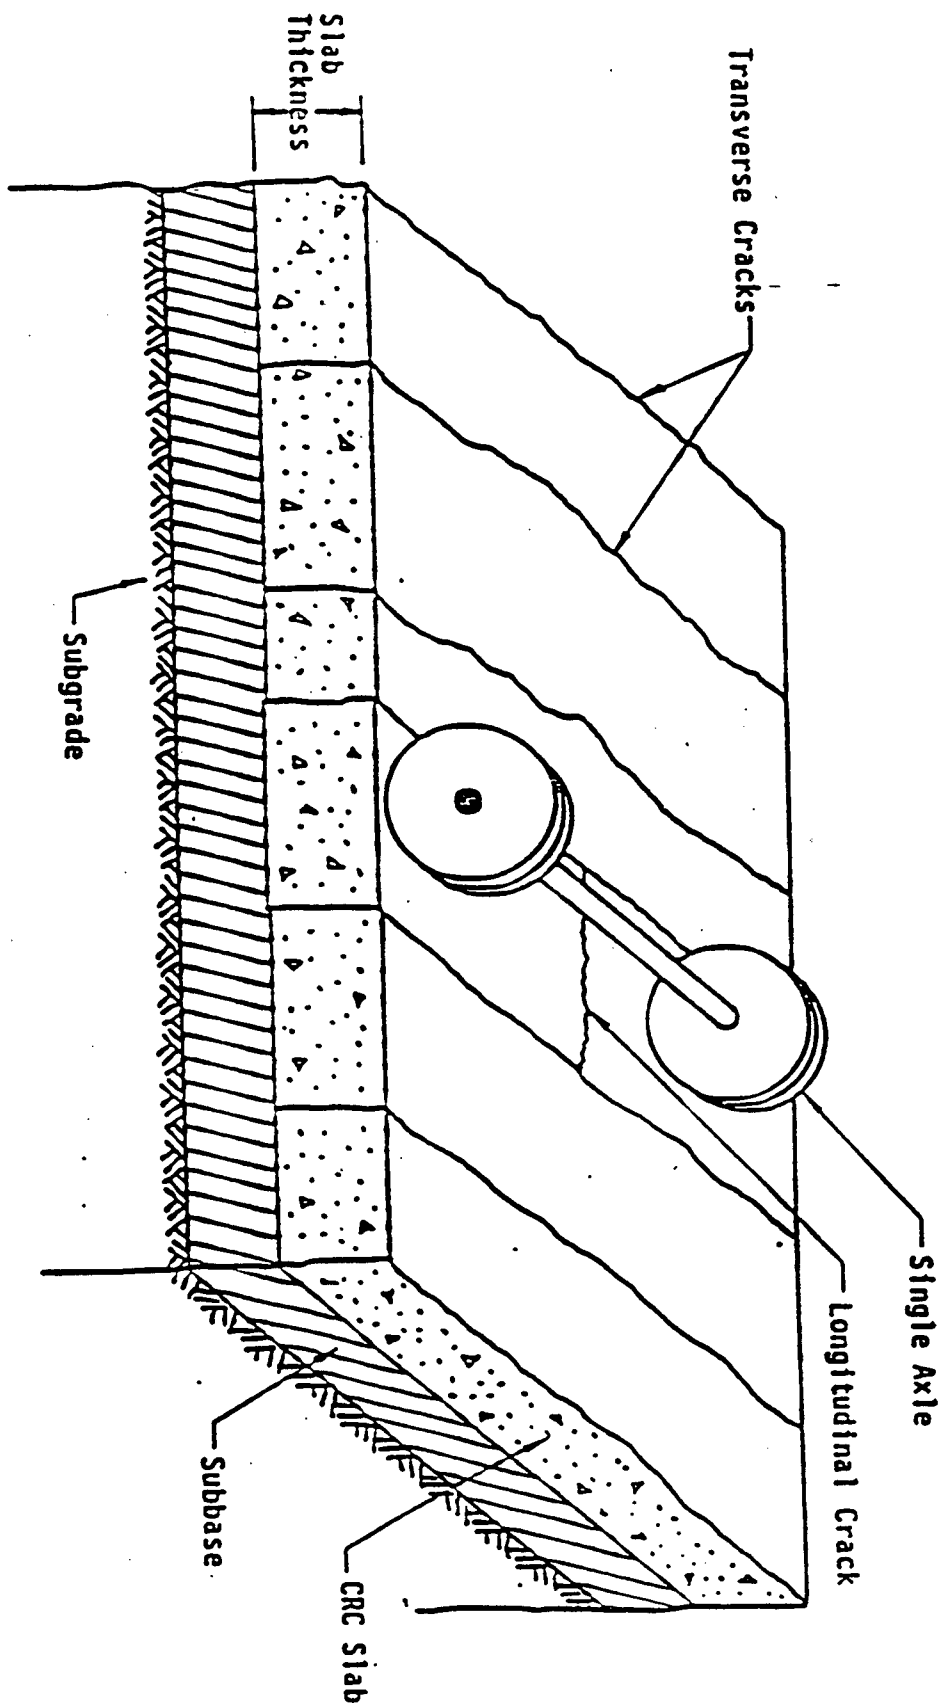
Figure 8. Formation of Longitudinal Crack Between Two Transverse Cracks - Intermediate State of Edge Punchout

The development of longitudinal cracking has long been associated with the formation of "punch out" distress, along with poor subgrade support and short transverse crack spacing. Figure 8 illustrates the location of maximum bending stress CRCP experiences in the transverse direction. Stress concentration is the primary factor leading to a longitudinal crack approximately 760 mm (30 inches) from the pavement edge, as witnessed by the performance monitoring during this study.

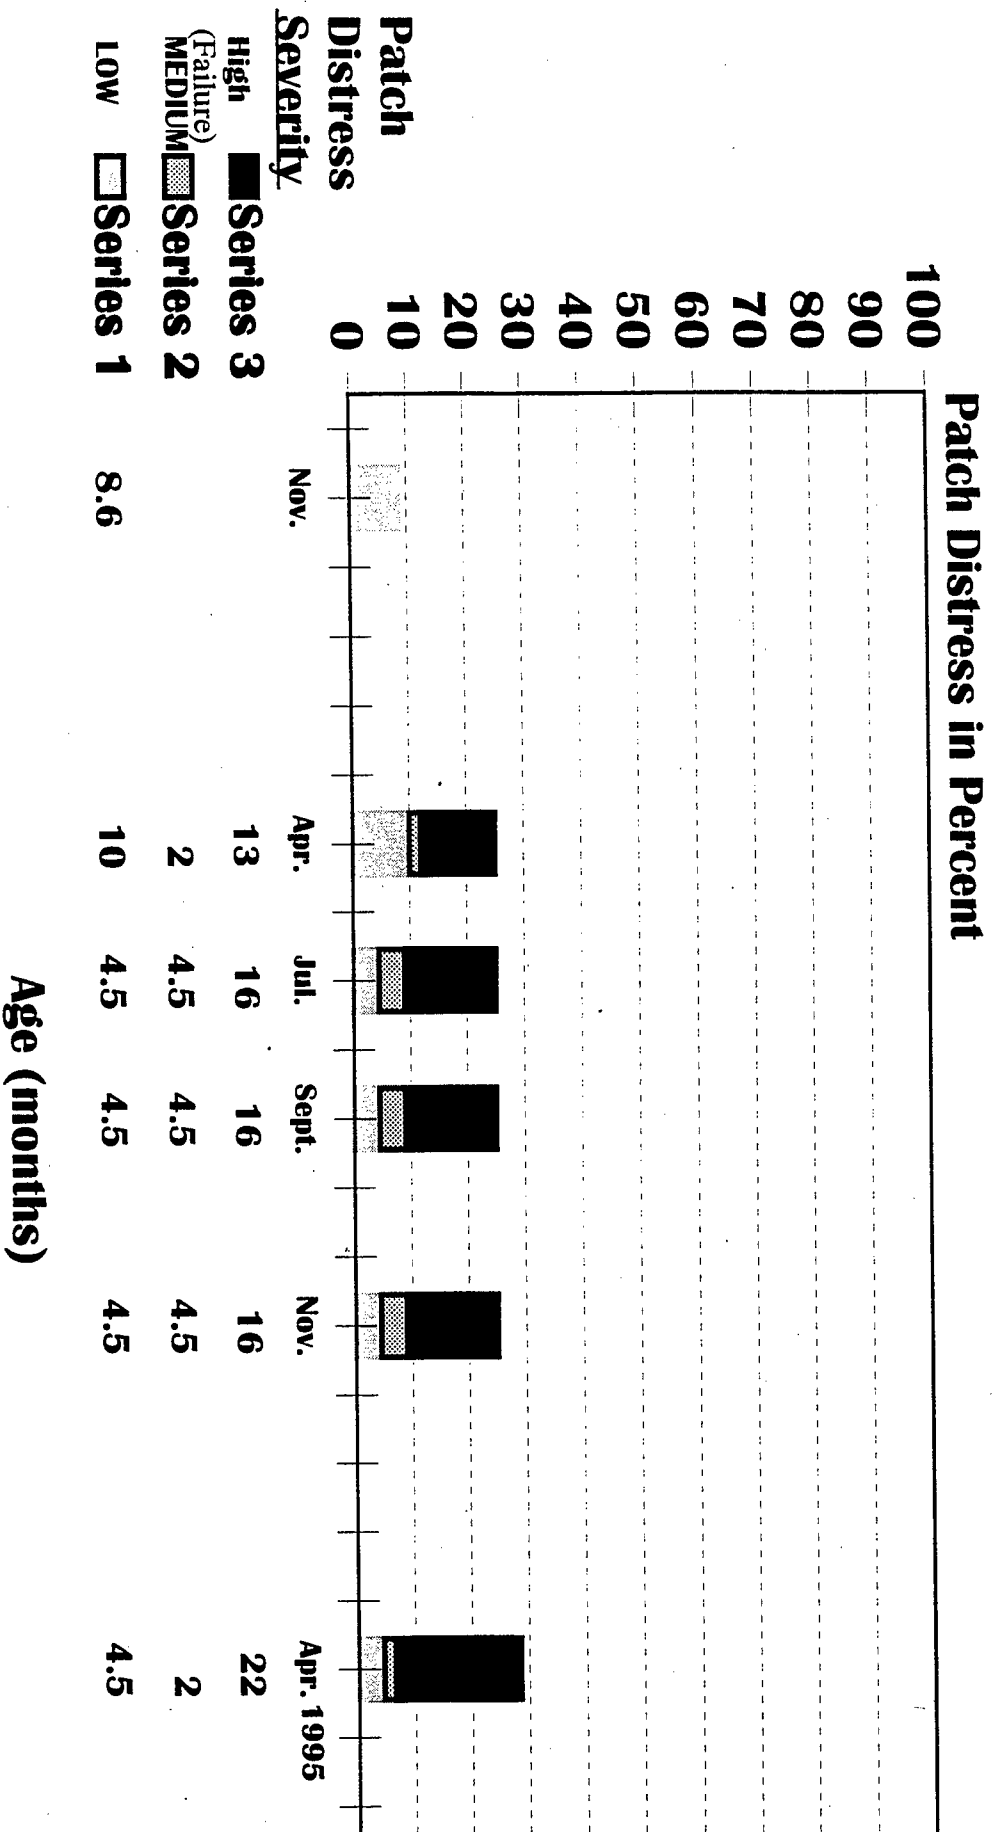
Figure 9. Steel Fiber Modified Concrete Patch Design

patches showed minimal distress at 2 months. Patches at Site 4 in Sangamon County contained only 44.5 Kg/cu. meter (75 lb/cu. yd) of steel fibers. These patches showed no improvement in performance over the conventional Class A patches. Patches of 7-inch CRCP at Site 5 in Douglas County contained 118.7 kg/cu. meter (200 lb/cu. yd) of steel fibers. These patches showed only marginal improvement (20% after 18 months) over the conventional Class A patches (see Figure 9). A reduced pavement thickness may have offset the strength gain of the steel fibers. The failure mode for the steel fiber modified concrete CRCP patch design was the formation of wide longitudinal and transverse cracks followed by punch outs, as depicted in Photo 16.

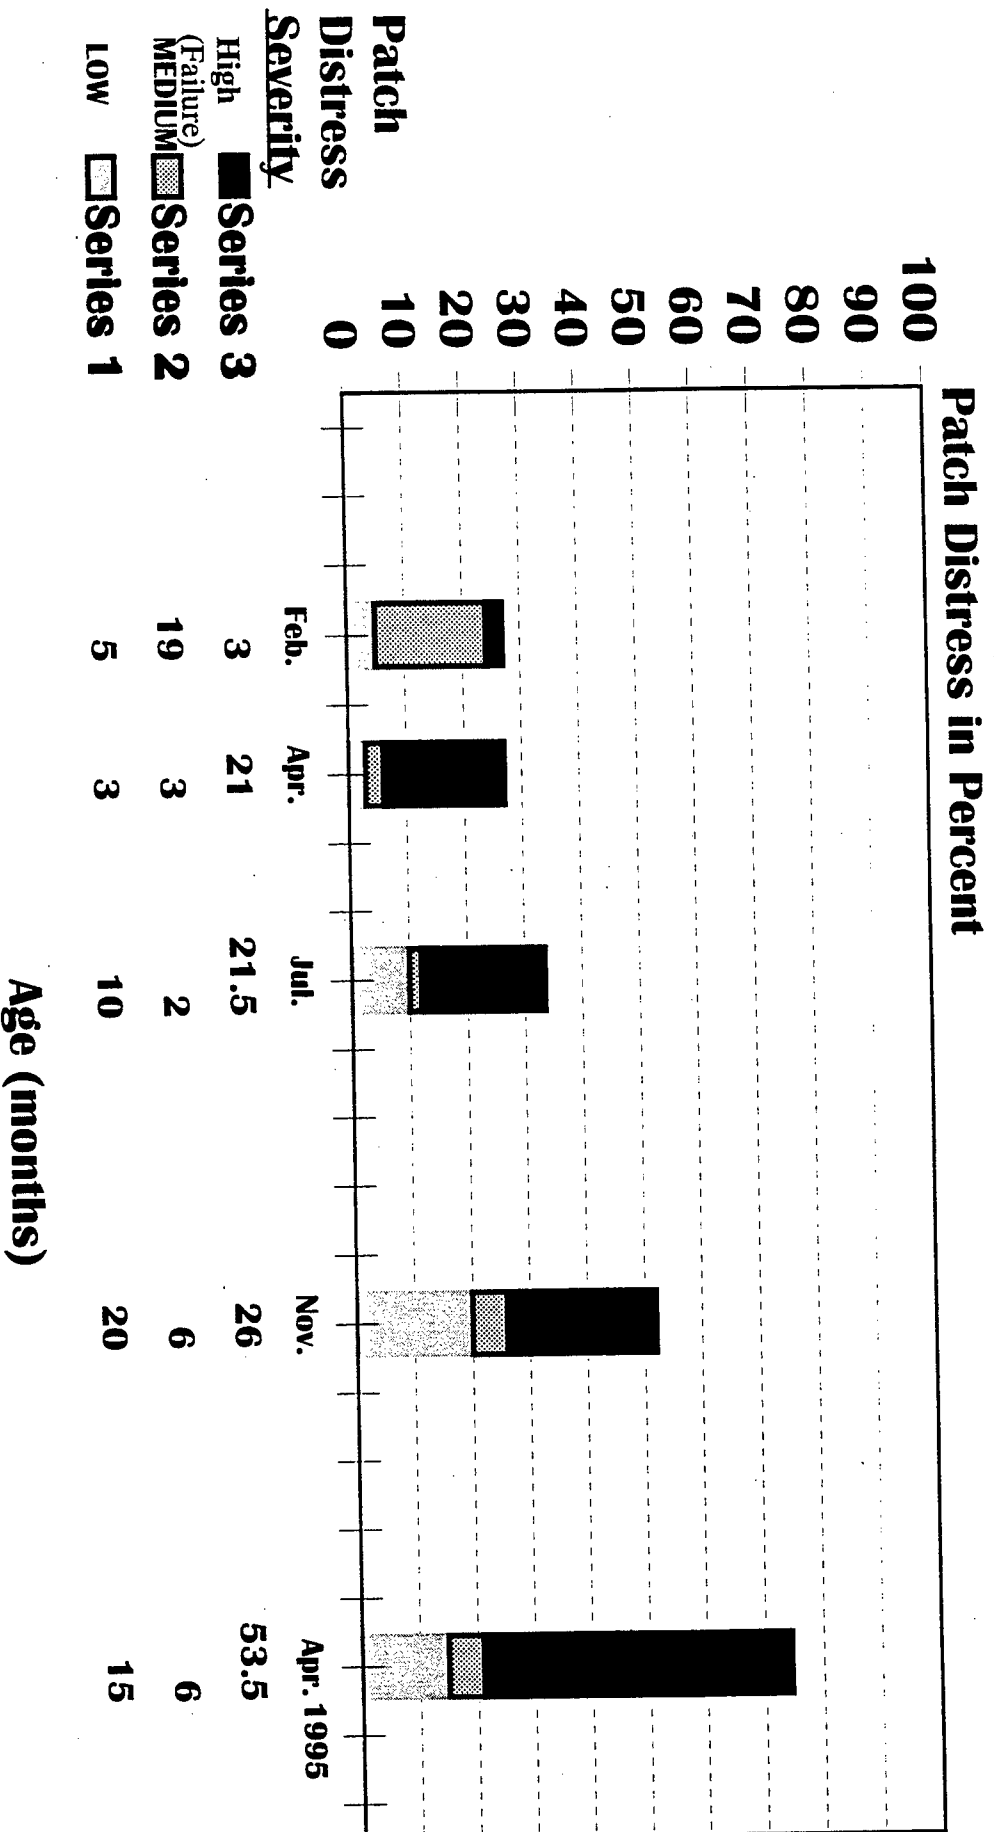
Figure 10. Drainage layer Patch Design

Survey data analysis indicates that over 75% of the patches failed completely in the two-year study period. Patch distresses ranged from spalling and longitudinal cracking to punch outs and pumping of fines. The design exhibited unexpected results with respect to the purpose of drainage. Figure 10 reveals an extremely high rate of patch failures. The fracture pattern of the majority of these patches showed that the excavation of the subbase between the rebar to be lap-spliced resulted in a loss of support between the rebar severed ends (see Photos 19-20). Drainage under the patch caused migration of subgrade fines, which washed through the underdrain network regardless of drain type. The drainage features actually allowed water to remain in the pavement, resulting in weakened subbase/subgrade support as indicated from CBR readings taken after the concrete was removed. It became evident that disturbance of the subbase/subgrade was responsible for the failures.

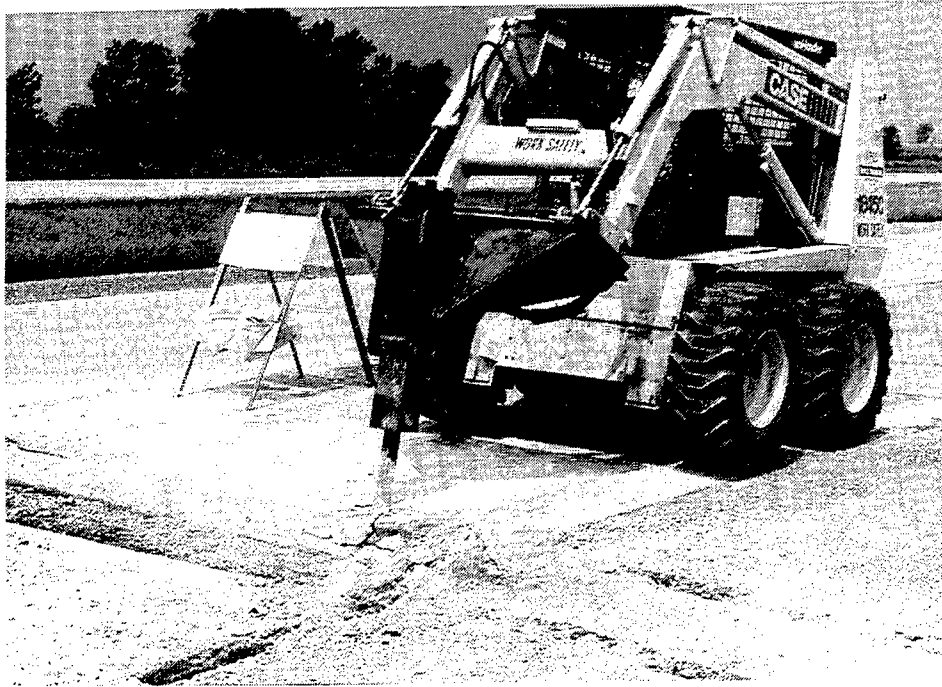
Photo 1. Skid-steer loader using mounted jackhammer to remove concrete.

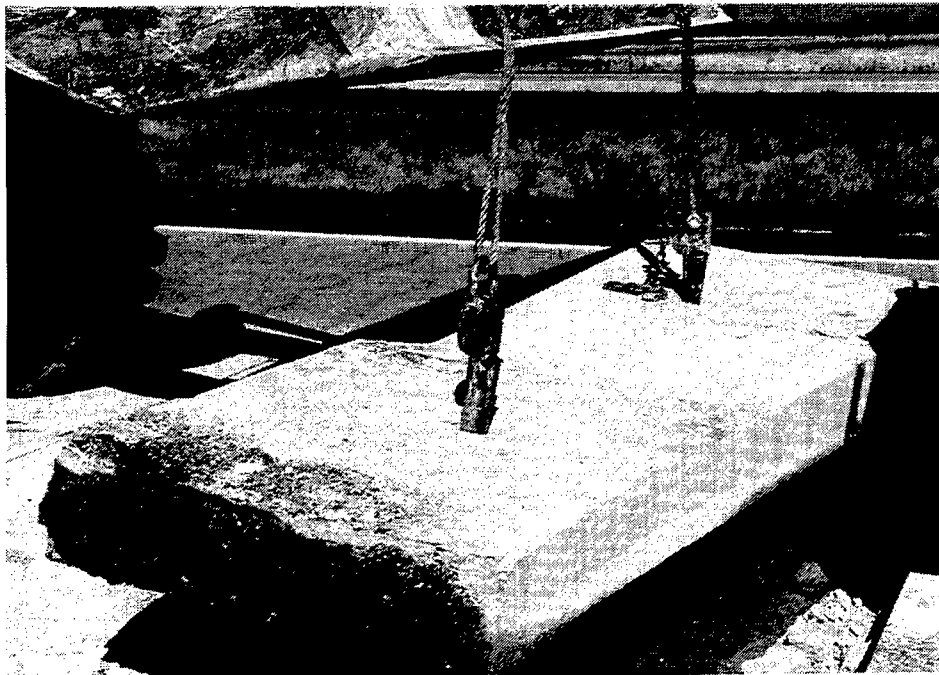
Photo 6. Slab lift-out method by the use of pins.

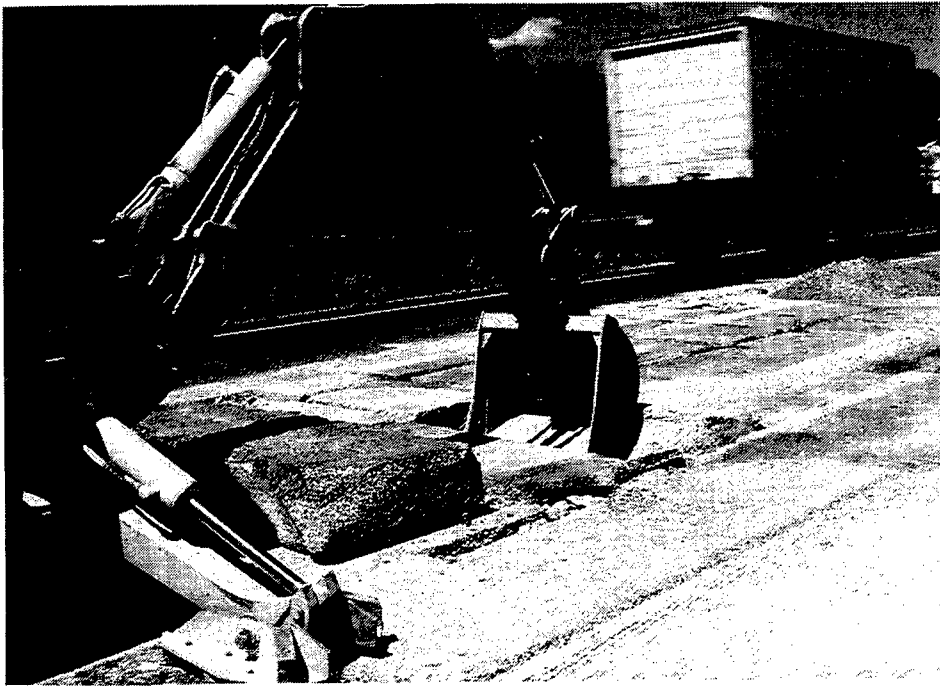
Photo 7. Removal of concrete by backhoe in segments.

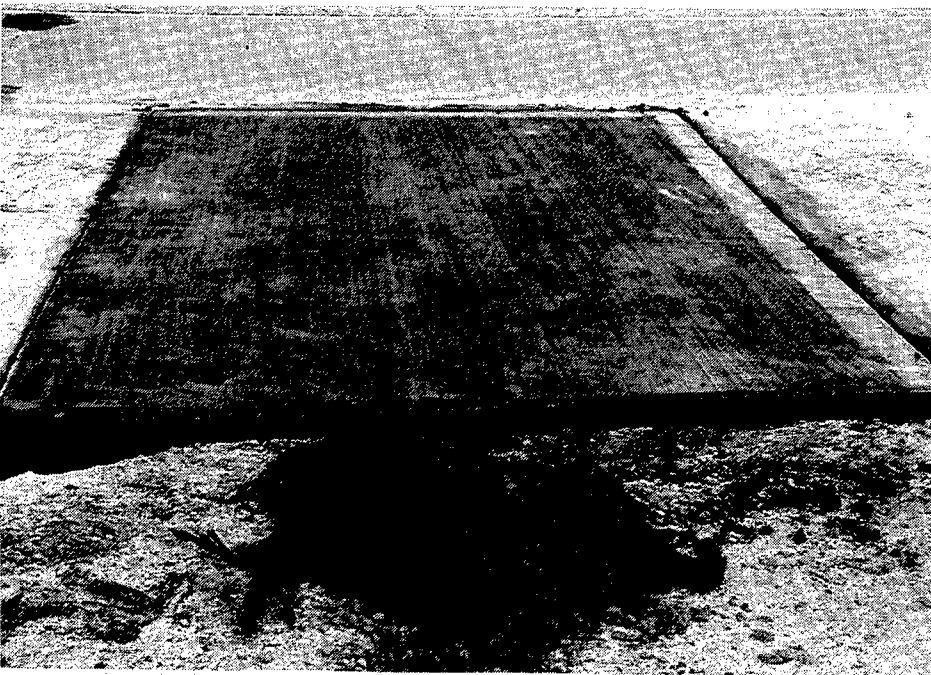
Photo 12. Edging of the patch perimeter to form sealant reservoir.

Patch joints were sealed using ASTM D 3405 hot poured sealant for 90 of the 132 patches. Refer to Special Provision for Joint Sealing Continuously Reinforced Concrete Patches. Photos 12 through 14 illustrate the hot poured sealant procedure. The 90 sealed patches were able to withstand large impact forces resulting from traffic loadings at all sites, but most notably, Site 1 in Logan County. Figure 7 shows a very low percentage of patch failures (4.5% after 18 months). Unlike other experimental CRCP patch designs in this study, the transverse rebar design did not have a high failure rate immediately after construction (see Photo 15).

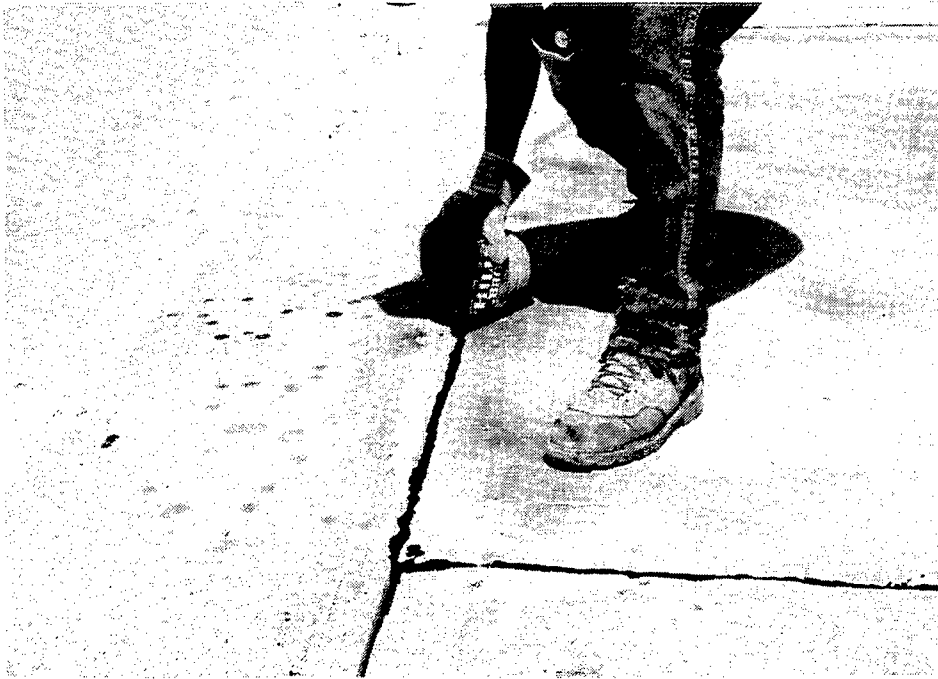
Photo 13. Pouring of joint sealant using ASTM D 3405.

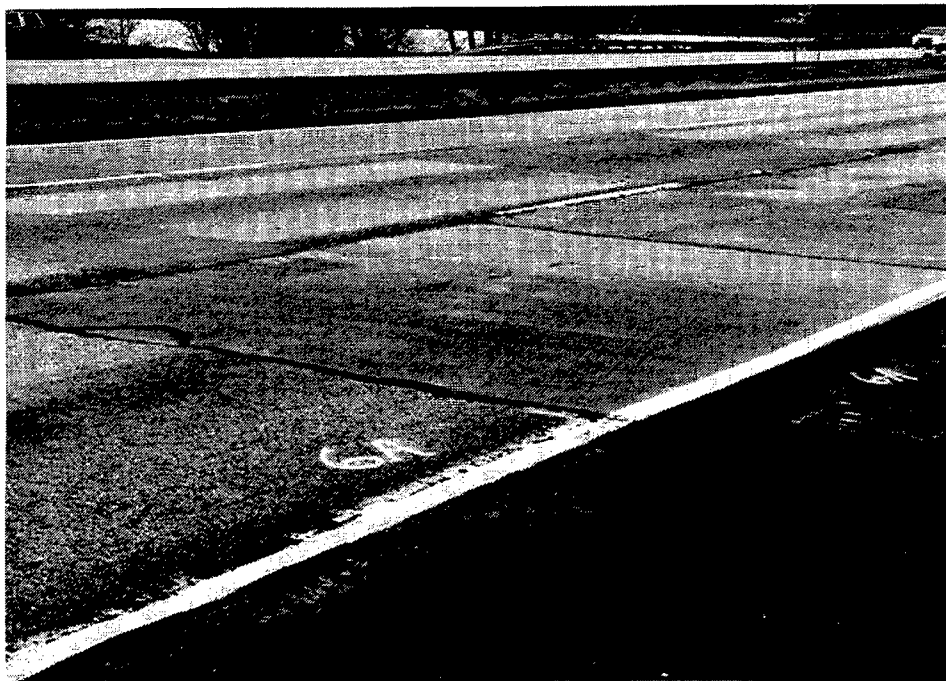
Photo 14. An example of a completed patch with joint sealing.
